RE: **Potential for Over- and Under-Infusion:** Novum IQ Large Volume Pump, Baxter Corporation

Please be advised that Baxter Corporation has issued **an urgent medical device correction for our current intravenous (IV) pump, the Novum IQ Large Volume Pump (LVP)**. Baxter has provided the following information:

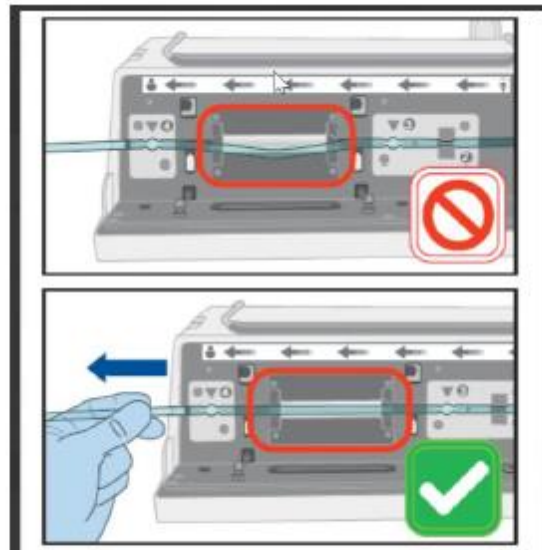
Failure to load the tubing properly into the pump channel may result in the pump infusing at a rate higher or lower than programmed.

1. Ensure:
 - a. The door is fully open before loading the set.

- b. The tubing is taut and loaded without slack in the pumping channel, as in Figure 1 below.
- c. Monitor patients frequently to ensure that the appropriate infusion is being delivered.
