MEMO

RE: CHS MED-RX Paracentesis Tray - Drainage Tube with Connector, Cardinal Health Canada (2025FCA64)

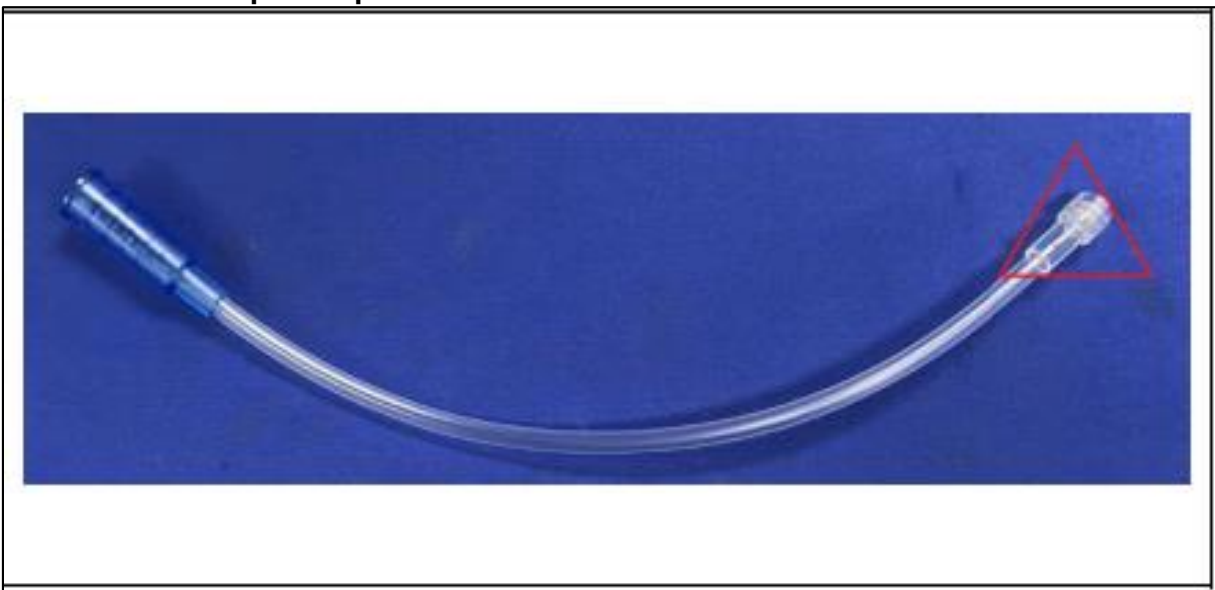
Thunder Bay Regional Health Sciences Centre has been alerted to **issues with CHS MED-RX Paracentesis Tray - Drainage Tube with Connector** (Supplier Code 10-1212BNS) in which the Luer lock component is susceptible to degradation when exposed to alcohol or alcohol-based substances, which may result in cracking or structural failure of the component prior to use.

80-7053 (10-1212BNS)	MED-RX Paracentesis Tray (Drainage Tube with Connection)	187367, 188442, 191555, 191940, 200793, 200798, and 203049
-------------------------	---	--

1. Inspect inventory for the lots of products listed above.
2. If this inventory has been affected, cracking or failure of the structural component may occur.

1. Inspect connection ends carefully prior to use.
2. If structural issues are apparent at time of inspection, immediately replace the tubing.
3. Monitor for leaking during use, and replace tubing if leaking is noted.
4. Complete an Incident Learning System report and reference the lot and expiration date of the tubing used.
5. Notify your Manager and provide him/her with the faulty product.
